REPORT OF INVESTIGATION

Underground Coal Mine  
Fatal Machinery Accident  
November 12, 2007

San Juan Mine 1  
San Juan Coal Company  
San Juan County, New Mexico  
ID No. 29-02170

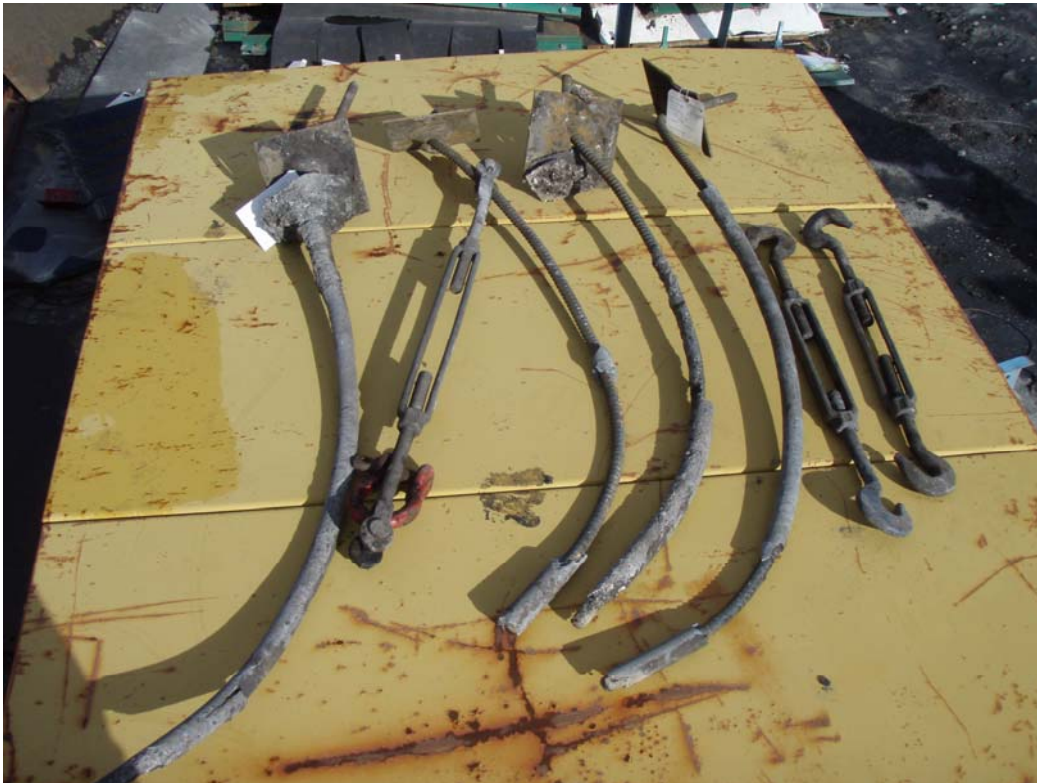
Once the two bolts severed, the four remaining bolts were pulled from the mine floor. Of the four remaining bolts, the grout encompassing the bolts was mostly intact on two of them. On the other two bolts, the grout was spalled from at least 50 percent of the bolt length. All four of the bolts that pulled out had two distinct curvature characteristics. Specifically, at the top of all four bolts, there was a near 90-degree bend

in each bolt. Then in the segment below the bend, there was a long, gradual curve in the bolt. The 90-degree bend appears to have occurred at or near the interface of the mine floor; that is, the sharp bend occurred where the bolt was protruding from the mine floor. The gradual bend would have occurred as the bolt was being pulled out of the mine floor.

PICTURE OF ANCHOR BOLTS THAT PULLED OUT OF FLOOR  
WITH THREE RECOVERED TURNBUCKLES

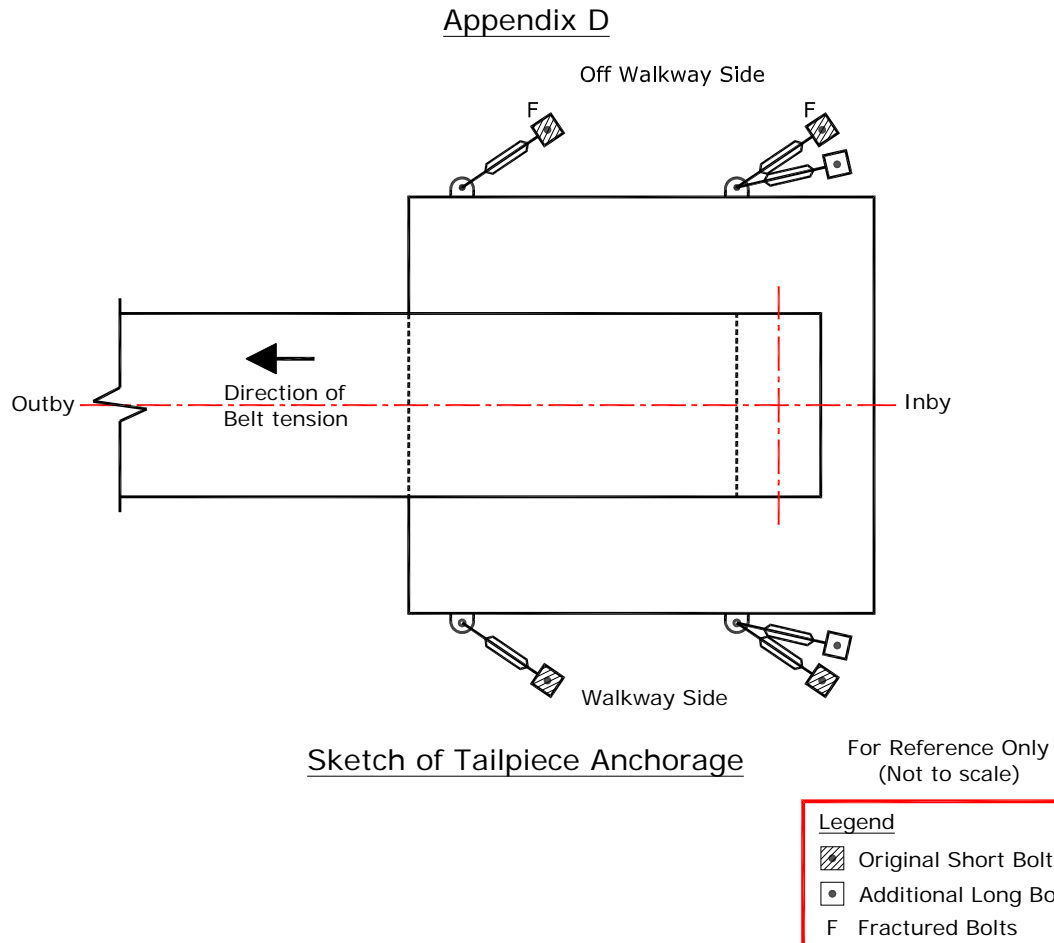
## APPENDIX D

The bolts were installed into the floor such that they were angled away from the direction of belt tension to increase their pullout resistance. Reportedly, one additional bolt was added on each side to the rear anchor point because shortly after the belt was put into service, a clevis was found to be spread open and the tailpiece had moved. The two additional bolts were 6 foot 6 inch-long Dwidag No. 7 bars. The original four turnbuckles were installed at an angle to the sides of the tailpiece. The two additional turnbuckles were installed more inline with the direction of the belt length. See Appendix D for a sketch of the tailpiece and anchor bolt locations.

Failure Sequence – At 4:39 p.m. on November 12, 2007, the two off-walkway-side bolts (one inby and one outby) failed first making a loud pop noise. Once the two bolts ruptured, the remaining four anchor bolts pulled from the ground. The first bolt to pull from the ground was likely the long off-walkway-side inby bolt. As the anchorage was failing the tailpiece was skewing and the belting was training toward the off-walkway side. According to witness reports and the direction of travel of the tailpiece, it is believed that the next bolts to be pulled from the ground were the two inby walkway side bolts, then finally the outby walkway-side bolt. The final pullout released the tension in the belt allowing it to slide into the rib and down the entry, overtaking and impacting the fleeing victim. After the accident the belt was found to have folded over toward the off-walkway side. See Appendix D for a sketch of the tailpiece, anchorage, and failed anchor bolt locations.

*Corrective Action:* The operator should engineer an anchorage system to safely resist the loads acting on the tailpiece.
